# Manhole Inspection Summary

Manhole # S29E\_\_017MH

Insp Date: **9/23/08 10:08 AM**

**Location** Address: **109 Vine St**

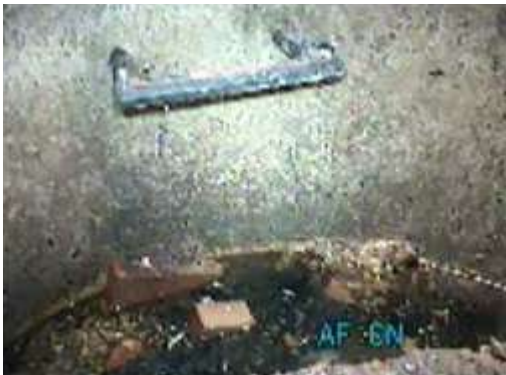
debris on bench

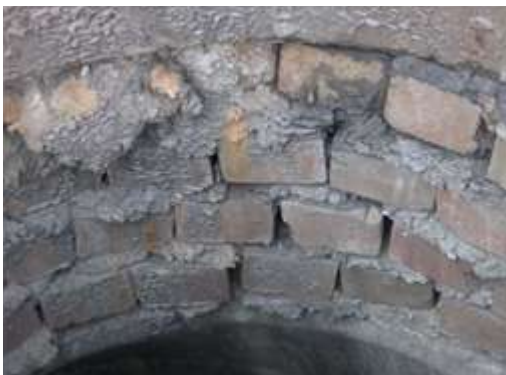
Defect 2

Condition: ☐ Sound ☐ Cracked ☐ Root Intrusion ☒ **Loose Brick** ☐ Deteriorated

Infiltration: ☐ None ☒ **Joint** ☐ Cracks ☐ Mortar ☐ Roots ☐ Wall

infiltration frame/chimney, loose bricks

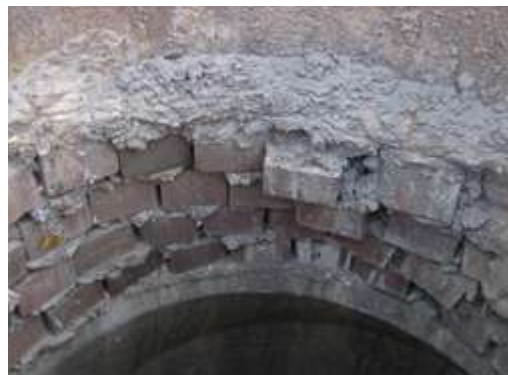
Defect 1

Condition: ☐ Sound ☐ Cracked ☒ **Leaks**

frame/lid infiltration

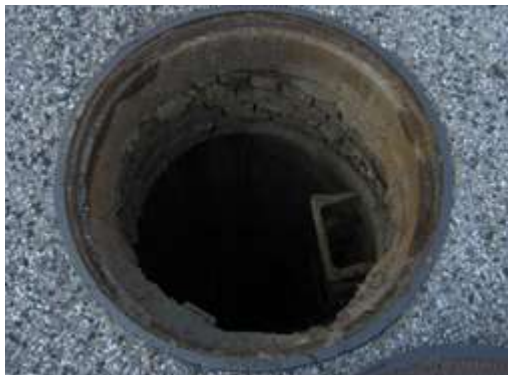
Defect 4

Offset: **3** (in.)

Frame offset

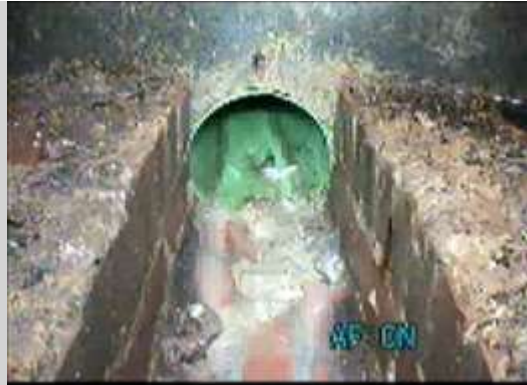
12 O'Clock Outflow

8 in. Circular Gravity Sewer  
Pipe Out @ 12 O'Clock

Deposits: ☐ None ☐ Mud ☒ **Sludge** ☐ Debris ☐ Grease

Silt Depth: **2** (in.) Deposits Extent: **Light**

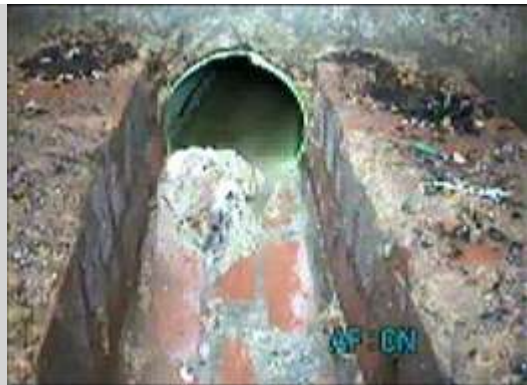
6 O'Clock Inflow

8 in. Circular Gravity Sewer  
Pipe In @ 6 O'Clock
